CHILD INJURY TOLERANCE THROUGH CASE RECONSTRUCTION

Alena V. Hagedorn

A basis for verification of child dummy injury criteria performance limits, ICPLs, is needed. Presently, the ICPLs used for child dummies are derived from the Hybrid III adult dummies using scale factors for size and strength considerations. This study presents the preliminary results of an ongoing effort to verify the ICPLs through reconstructions of real world incidents which have resulted in child injuries.

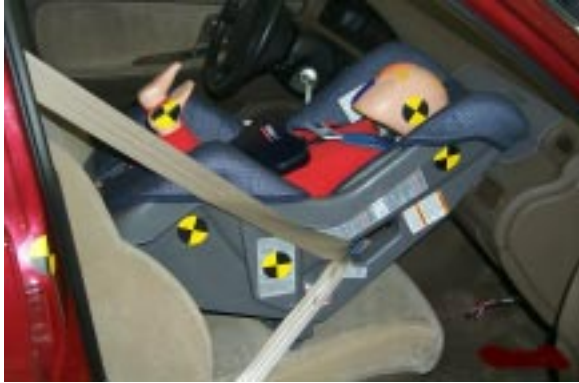
Test Setup Three passenger side static air bag deployments were conducted in a representative vehicle of the same make and model as the actual crash. The CRABI 12-month-old infant was positioned in a rear facing Century S.T.E. Car Seat 2000. The right front seat was forward of the mid-track position situating the child seat near the air bag module cover (Figure 1).

As in the actual case scenario, the child seat was set up incorrectly with the harness improperly routed through the top slots. The vehicle seat belts were also routed incorrectly with the lap and shoulder belts inserted through the holes intended for the forward facing configuration (Figure 1).

Figure 1. Set up for Reconstruction Test #1000.

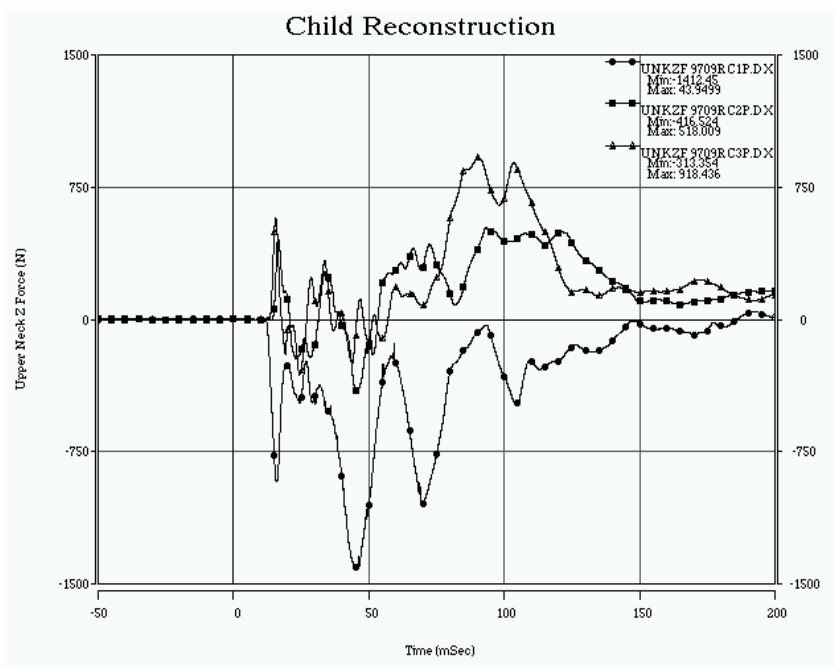
Further evidence of the air bag pushing the head downwards can be seen in the high value for neck compression, 1412 N (Table 4, Figure 2). Additional analysis of the data in the first test indicated head Z acceleration (Figure 3) was higher than anticipated (all processed data follows SAE- J211 sign convention).

Figure 2. Reconstruction #1000 upper neck Z force.

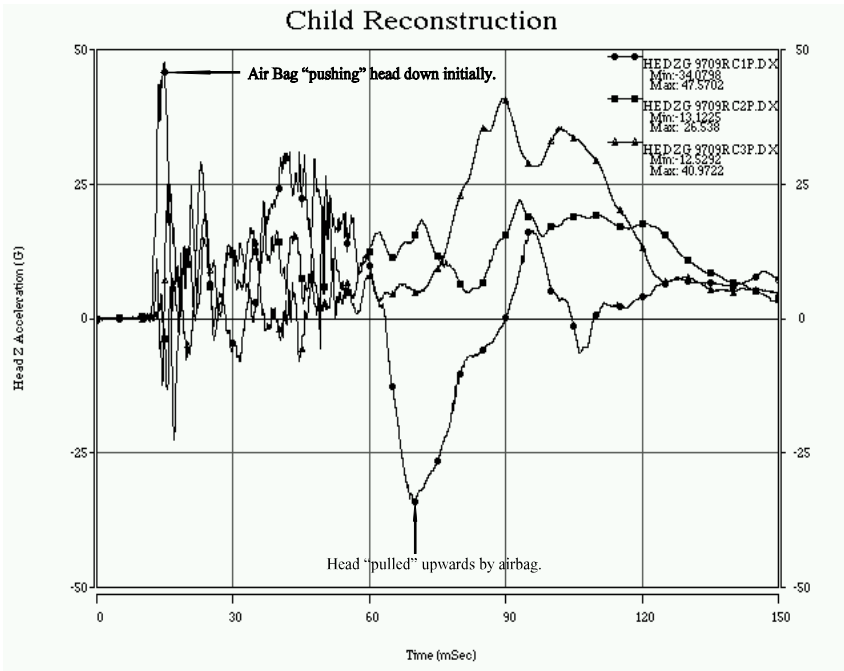
Figure 3. Reconstruction #1000 head Z acceleration.

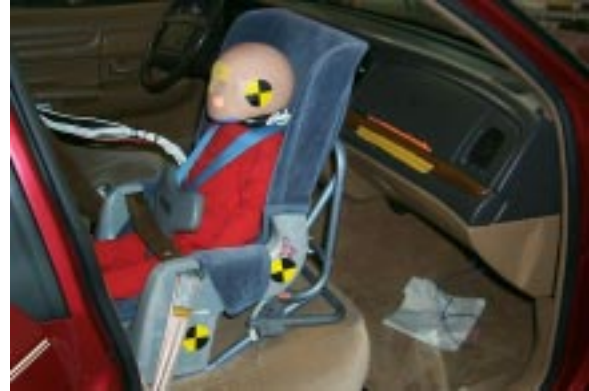
Test Setup Four passenger side static air bag deployments were conducted in a vehicle of the same make and model as the crash, with the CRABI 12-month-old infant in a rear facing Fisher Price Model 9100 Car Seat with a T-shield configuration (Figure 4). The right front seat was positioned 3.8 cm rearward of the seat track midpoint. This position was selected since investigative evidence from the actual crash showed no interaction of the air bag module cover with the back of the child seat.

Figure 4. Setup for Reconstruction Test #1200.

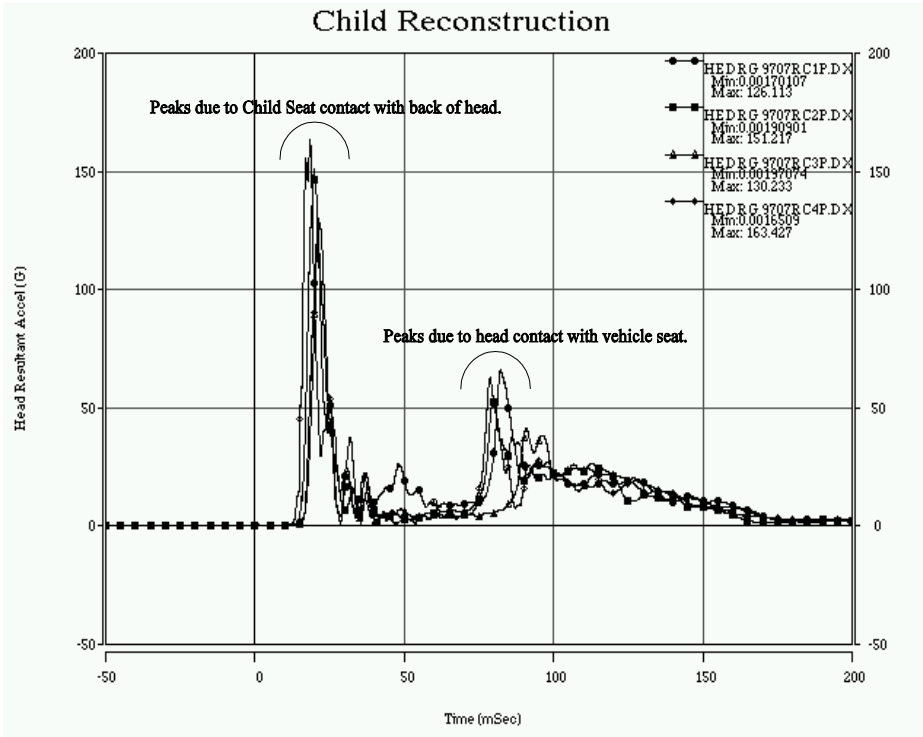
Injury criteria results for reconstruction series #1200 are shown in Table 7. In all four tests, the HIC (15 msec) exceeded the performance limit of 390. Head resultant accelerations ranged between 126 and 163 G (Figure 5). High head accelerations occur early in the event during the interaction of the air bag with the back of the child seat.

Figure 5. Resultant head accelerations from reconstruction series #1200.

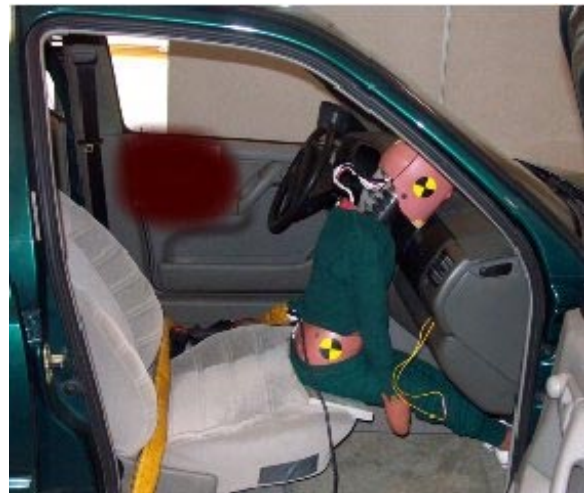
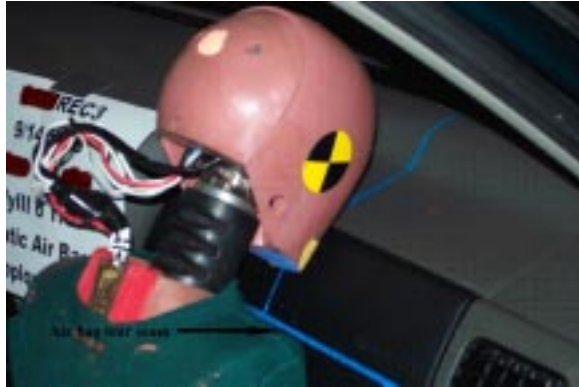
Three passenger side static air bag deployments were conducted in a vehicle of the same make and model as the crash, with the Hybrid III 6-year-old. The right front seat was positioned near the center of the track. The 6-year-old dummy was positioned leaning forward with chin resting on the air bag cover flap 1 3/4" above the flap tear seam (Figures 6 and 7). Tissue fragments from the case-child's chin were found at this location on the flap cover.

Figure 6. Setup for Hybrid III 6 year-old in reconstruction case #1100.

Figure 7. Setup for reconstruction #1100 showing head relative to air bag.

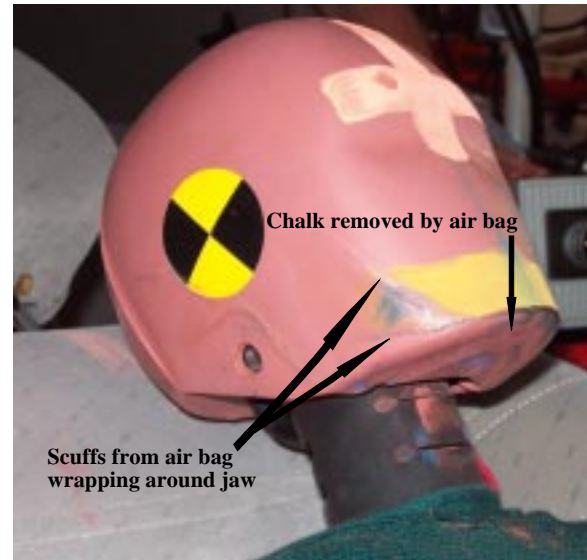
Results and Conclusions Film analysis and post test examination of the dummy revealed that the air bag deployed with the top flap contacting under the chin. The air bag then unfolded under the chin and along the anterior neck. The bag also wrapped around the chin along the jawline (Figure 8). Injuries sustained by the occupant, including a broken jaw and scrapes along the chin and neck are consistent with chalk displacement and abrasions on the Hybrid III 6 year-old dummy.

Figure 8. Evidence of air bag "wrapping" around chin on test dummy.

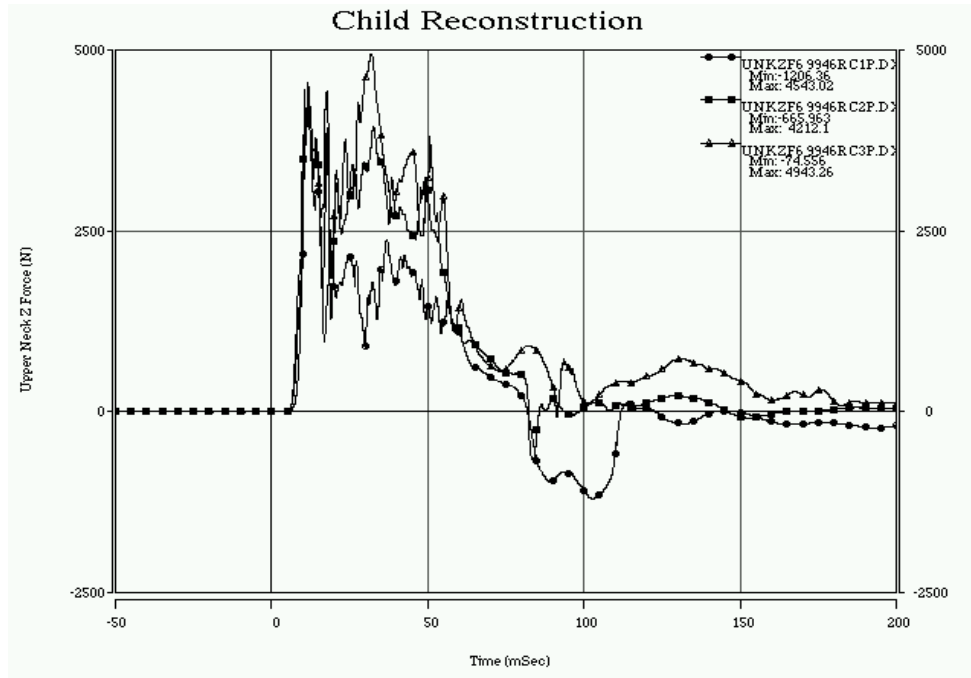
The neck load cell responses showed that the neck was forced into an extension-tension mode with peak loads well above 4000 N (Table 10) at the upper neck (Figure 9). The magnitude of these loads is consistent with the neck injuries received by the 7 year-old victim in this case who suffered transection of the spinal cord in the neck.

Figure 9. Upper neck Z force for reconstruction test #1100.

When evaluating the potential for neck injury in this reconstruction series, the N_{ij} values (Table 10) are well above the 1.0 performance limit, as expected. HIC values are below the 700 level in all tests which suggests a low probability of serious head injuries. This is consistent with the minor head injuries of the case occupant, with the exception of the fractured left mandible. However, HIC is not expected to be a good predictor of mandibular injuries.
